THE MUNICIPALITY OF
CHESTER

GOLD RIVER BRIDGE

A SUMMARY of the
FINDINGS OF THE
CONDITIONS
ASSESSMENT REPORT

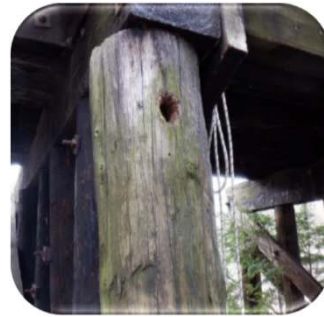
Animal and insect damage

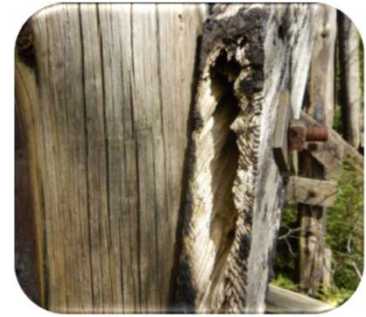
Decay

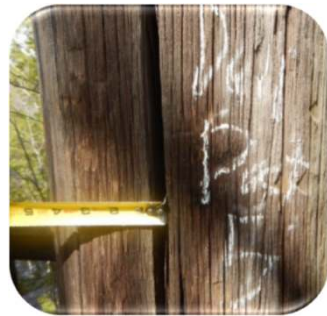
Cracked timbers

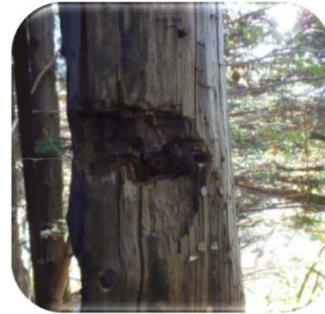
Vandalism

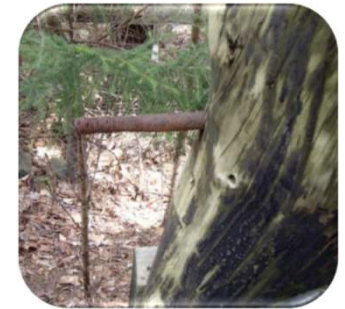
Rusting and missing hardware

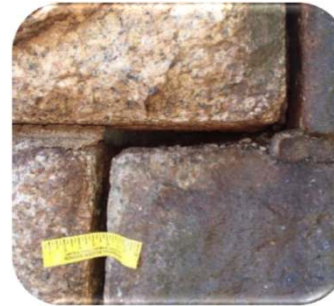
Missing masonry

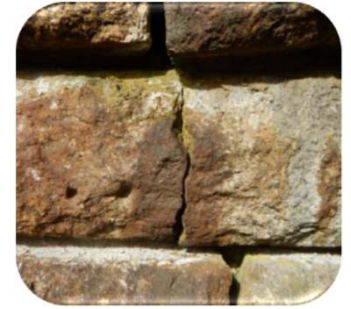
Cracking

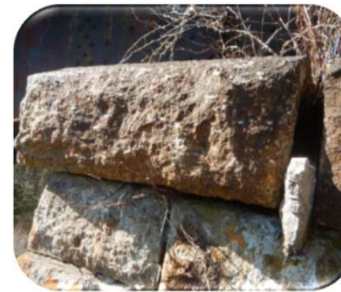
Shifting and cracked top caps – allows water to get in

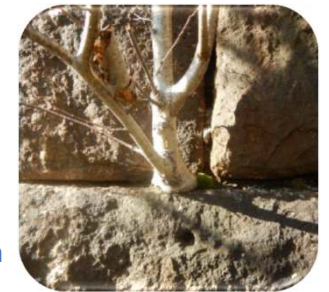
Vegetation

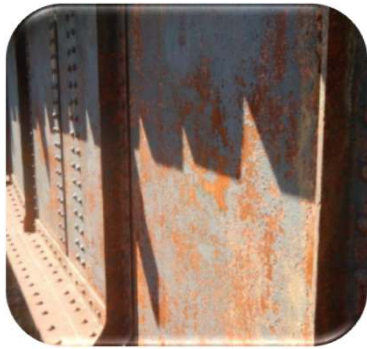
Surface coating failure

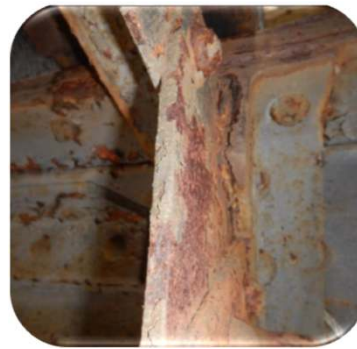
Pack rust on lateral braces

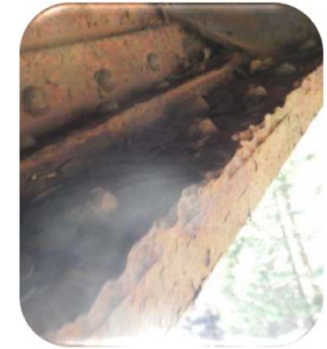
Pitting and corrosion on flanges

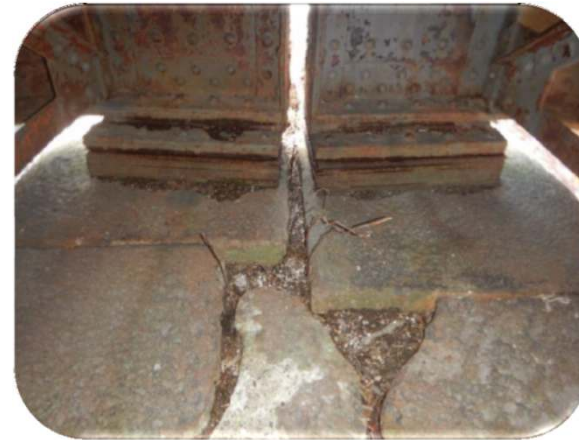
The central bearings have failed and no longer slide

This failure transfers the movement of the girders down into the piers creating a 'vertical cantilever'. Think of how a flagpole wobbles at the top while the bottom stays fixed.

Corrosion and no evidence of 'sliding' as would be expected

This is an issue because the piers, whose condition is also compromised, were not designed to accommodate the lengthwise and side-to-side forces.

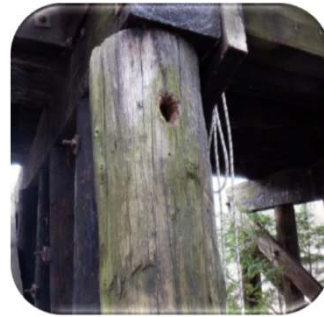
Animal and insect damage

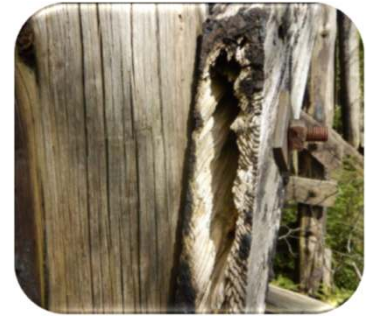
Decay

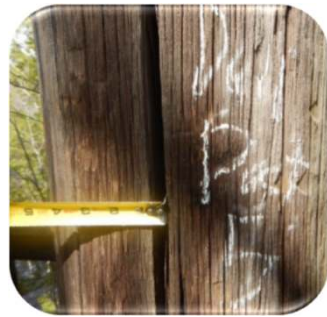
Cracked timbers

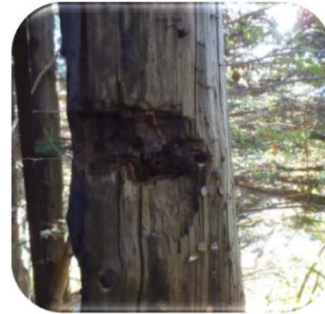
Vandalism

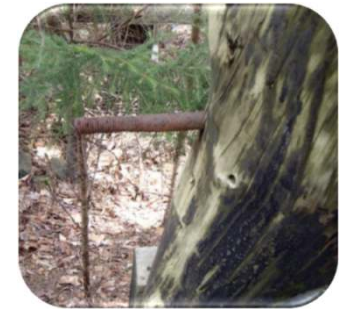
Rusting and missing hardware

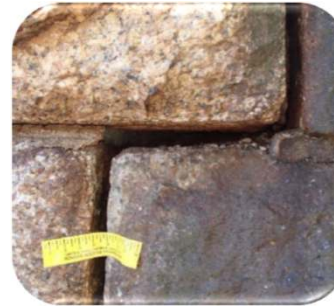
Missing masonry

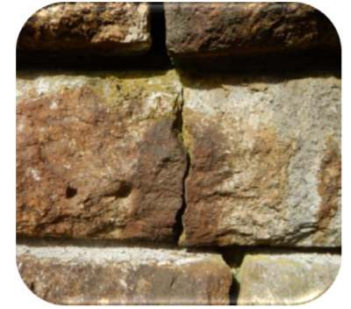
Cracking

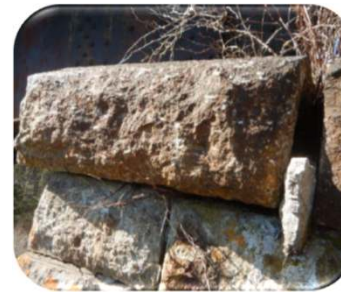
Shifting and cracked top caps – allows water to get in

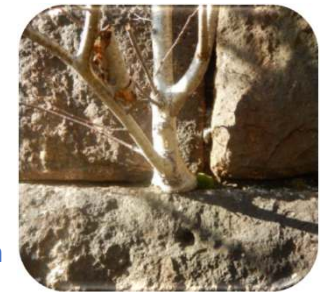
Vegetation

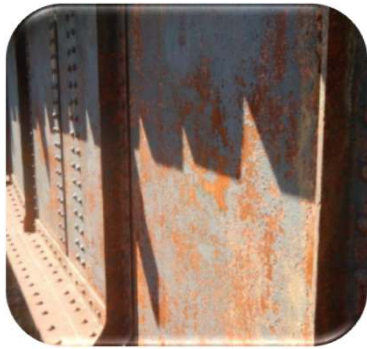
Surface coating failure

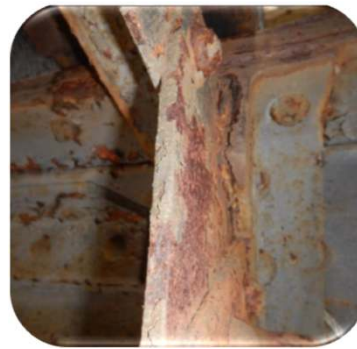
Pack rust on lateral braces

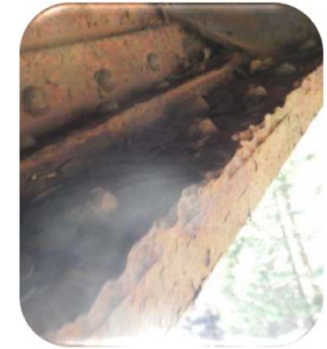
Pitting and corrosion on flanges

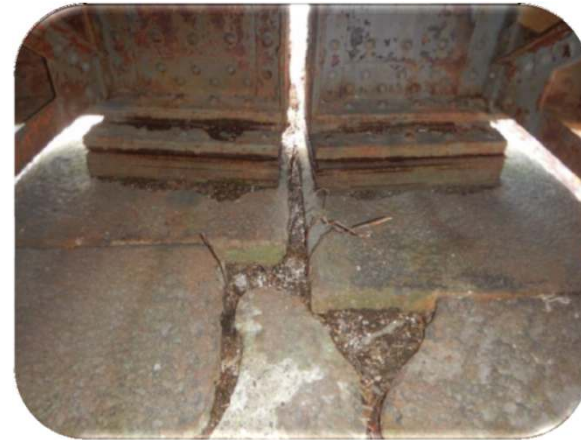
The central bearings have failed and no longer slide

This failure transfers the movement of the girders down into the piers creating a 'vertical cantilever'. Think of how a flagpole wobbles at the top while the bottom stays fixed.

Corrosion and no evidence of 'sliding' as would be expected

This is an issue because the piers, whose condition is also compromised, were not designed to accommodate the lengthwise and side-to-side forces.
