THE MUNICIPALITY OF
CHESTER

GOLD RIVER BRIDGE

A SUMMARY of the
FINDINGS OF THE
CONDITIONS
ASSESSMENT REPORT

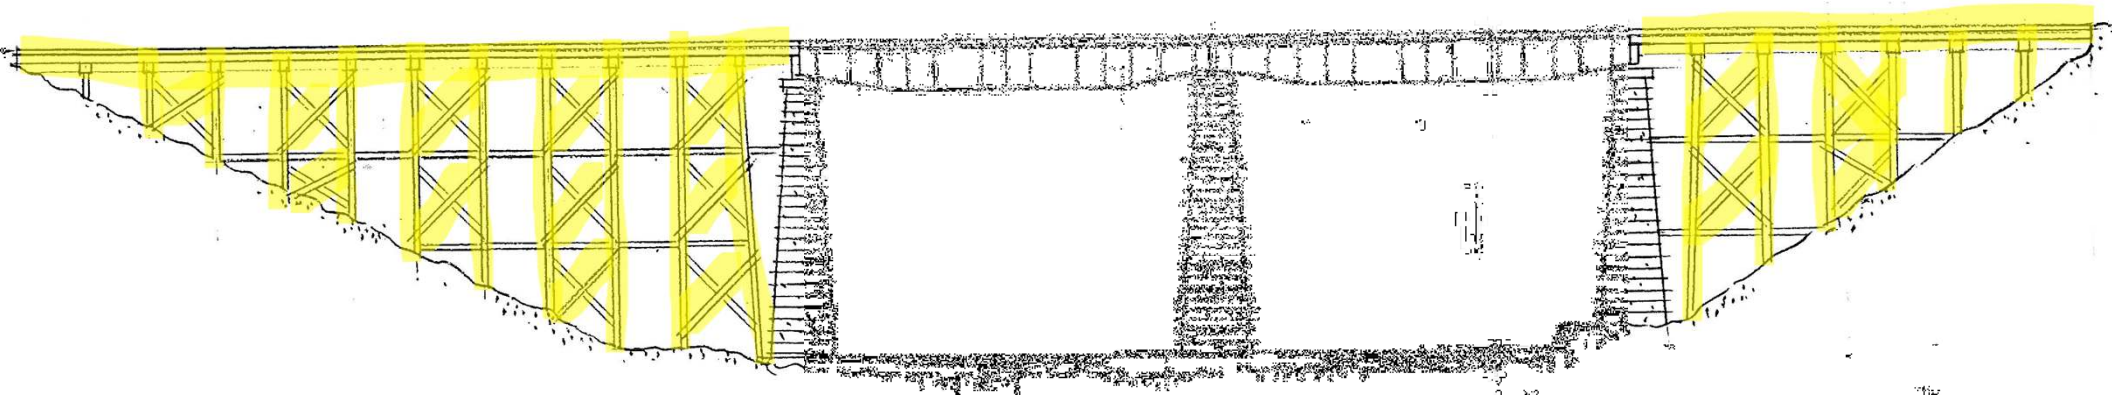
OBSERVATIONS: Timber Trestles

- The lifespan of creosote timbers is typically 50 years
- Many timbers are in very good condition. However, some have degraded rapidly in recent years due to:

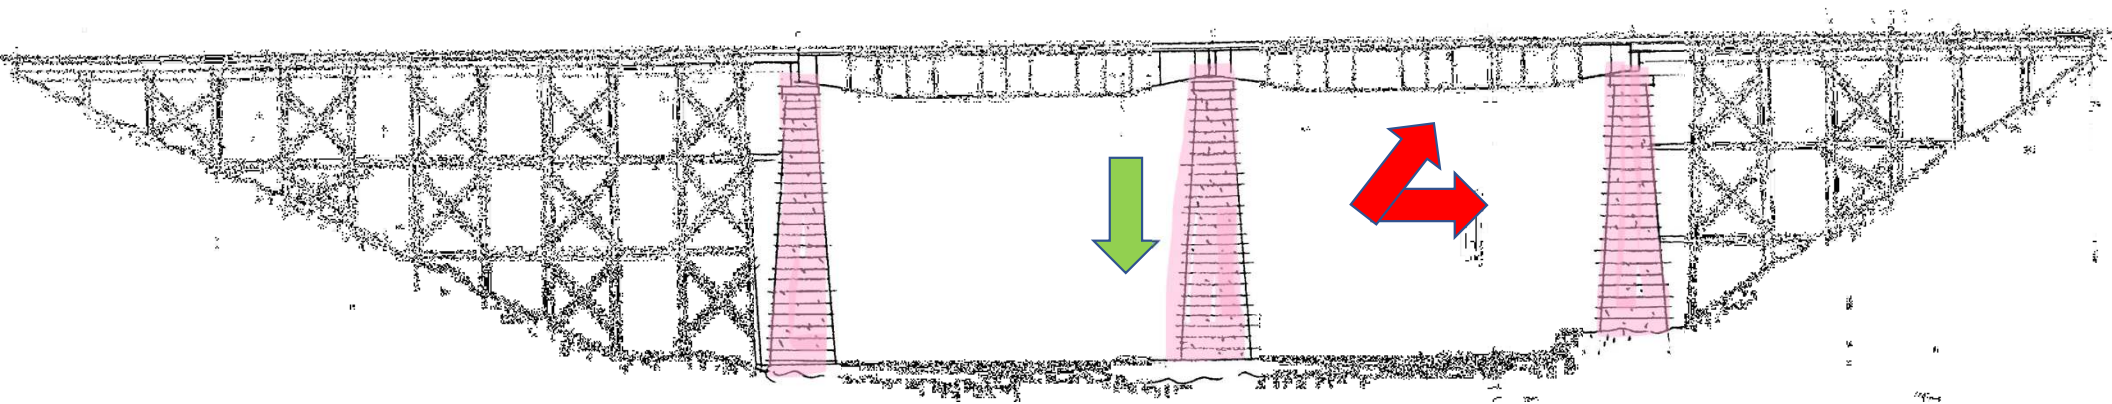
OBSERVATIONS : Stone & Masonry Piers

Piers are intended to support downward forces

They are not intended to support lengthwise or side-to-side forces

The piers have degraded in recent years due to:

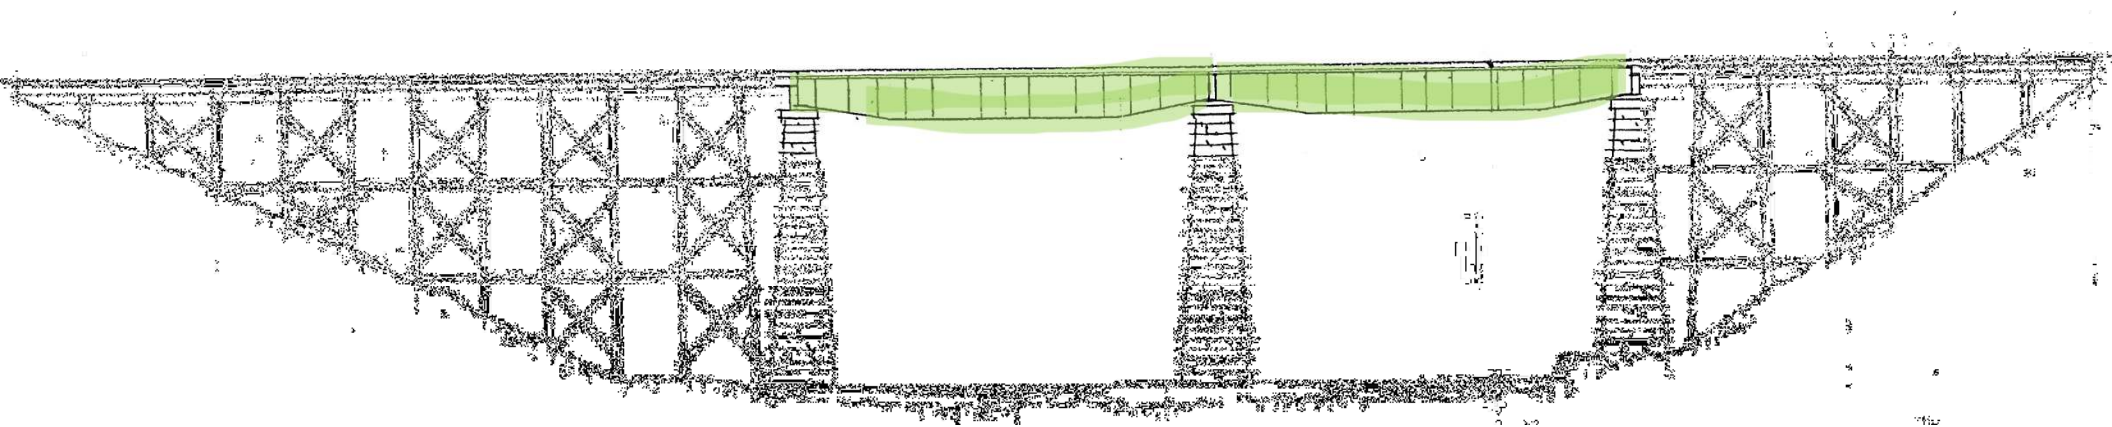
OBSERVATIONS: Steel Girders

Degradation has progressed in recent years due to:

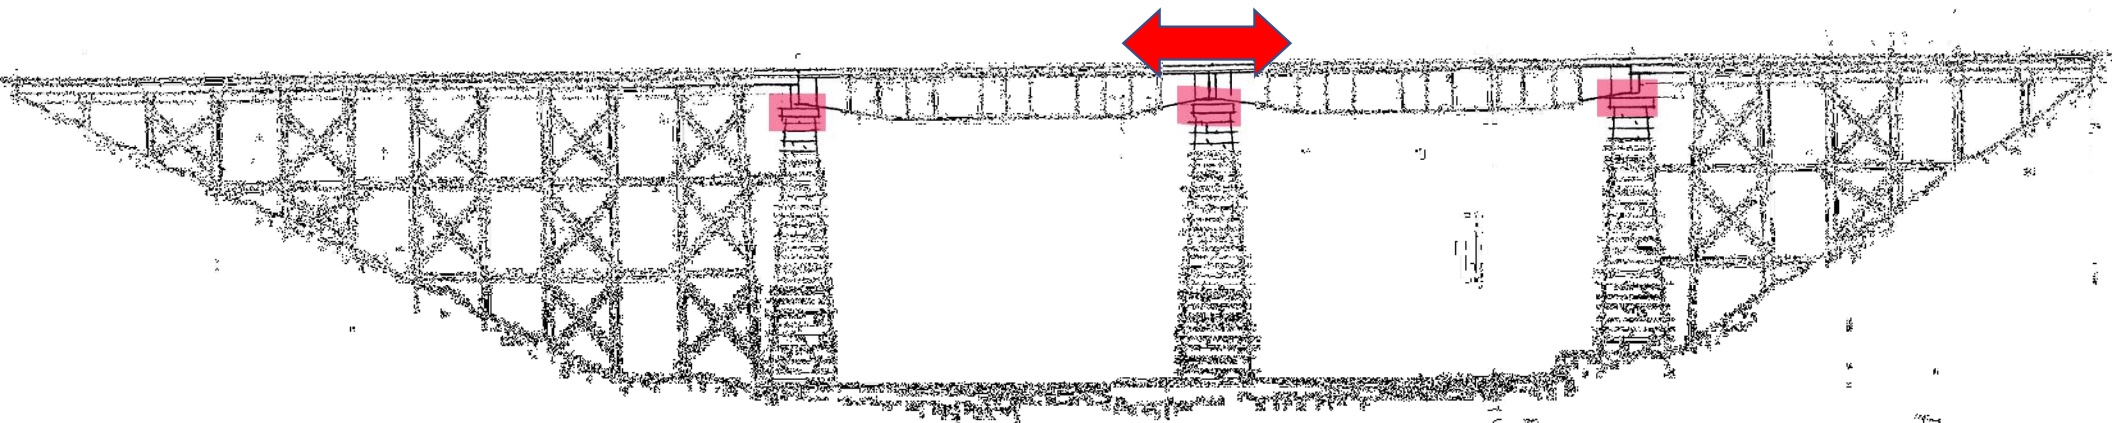
OBSERVATIONS: Bearing Plates

Bearing plates sit between the steel girders and the stone piers

The east and west end bearings are fixed

The central bearings are designed to slide to accommodate the expansion/contraction of the steel

The central bearings have failed and no longer slide

This failure transfers the movement of the girders down into the piers creating a 'vertical cantilever'. Think of how a flagpole wobbles at the top while the bottom stays fixed.

Corrosion and no evidence of 'sliding' as would be expected

This is an issue because the piers, whose condition is also compromised, were not designed to accommodate the lengthwise and side-to-side forces.
